ENERGY AUDIT

STUDY PERIOD (TWO YEARS) 2021 - 2022 & 2022 - 2023

Sustainability study **RENEWAL AUDIT REPORT**

**Studied for
Rama University**

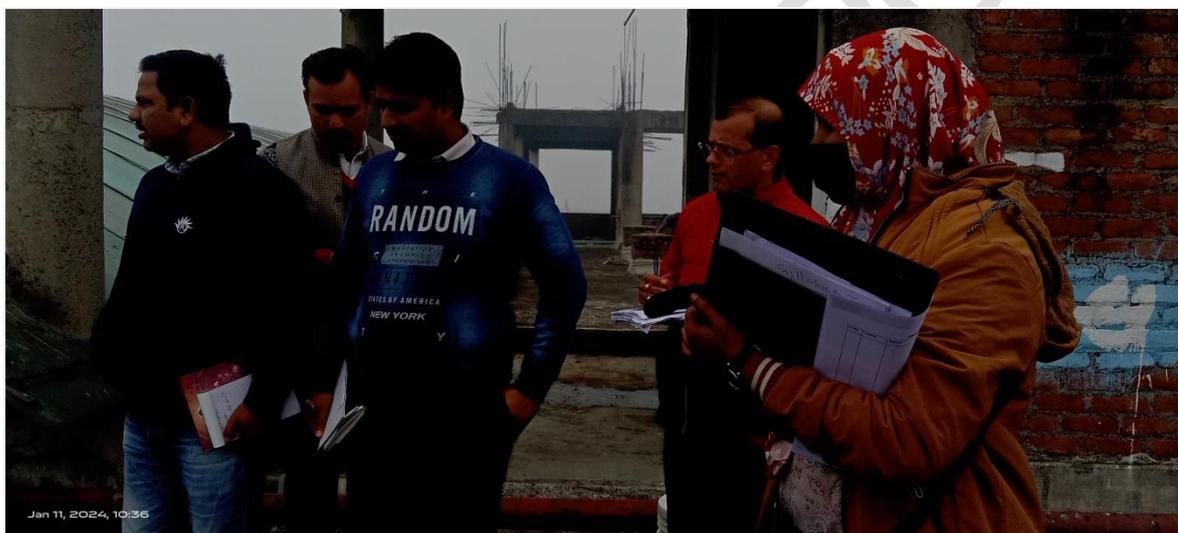
Plate 1: On-site investigation of the premises

The compliance study is focused on photographic documentation done during the site visit on 11 January 2024

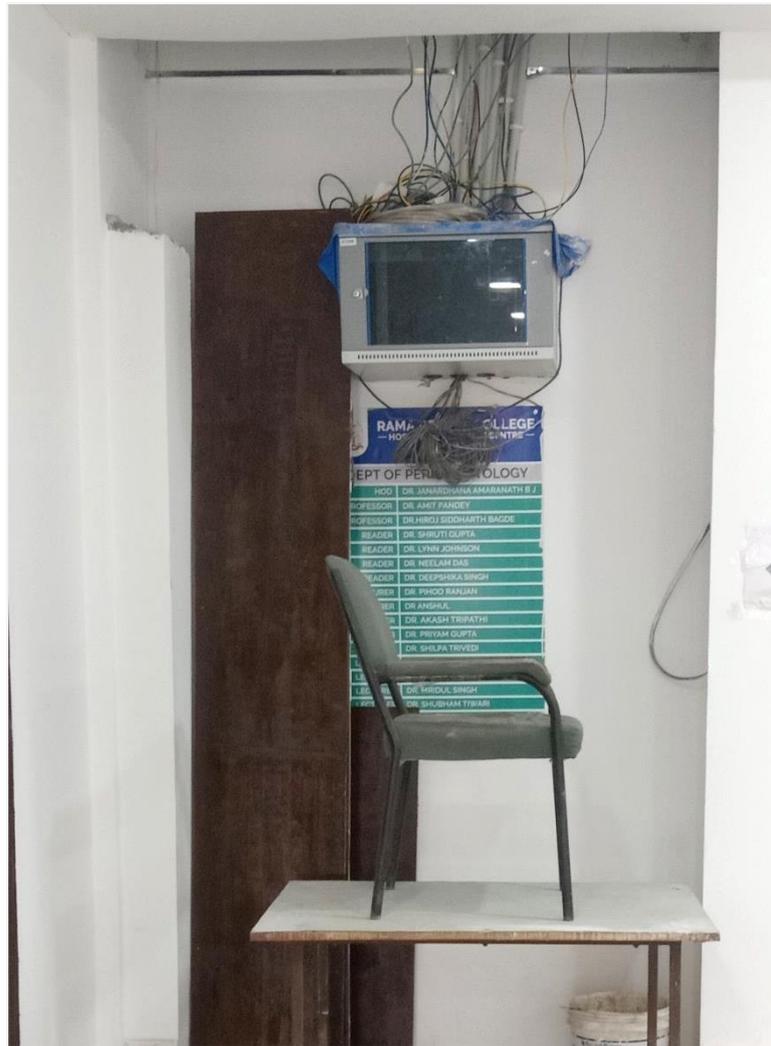
Plate 2: Exposed wiring study

Observation: The exposed wirings in the internal spaces

Inference: *The study suggests that:*

- ➔ *The **wirings are exposed and needs concealing** with proper fabrication*
- ➔ *There should be **a stabilizer** for this space*
- ➔ *Additional, **UPS and power backup** should be provided*
- ➔ *Given the current space and its usage, safety precautions such as signages, **fire balls/ sand bucket** should be places to avoid any fire accident*

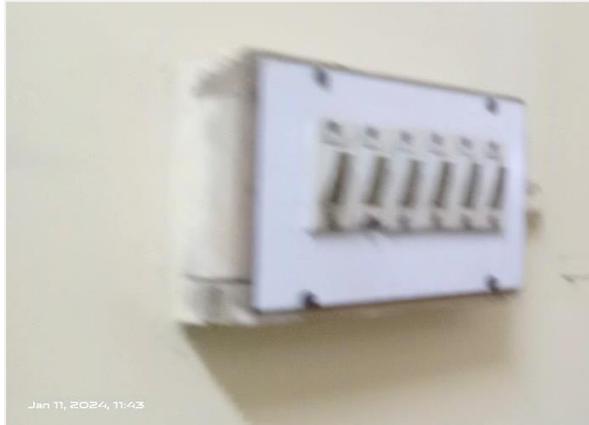
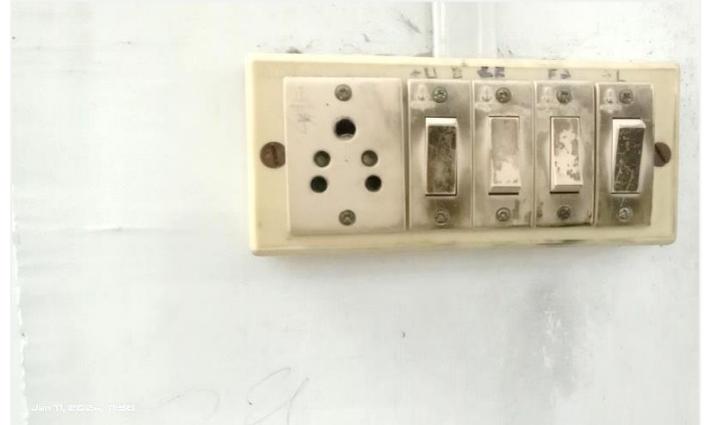
Plate 3: Switchboards study

Observation: Seems like an electrical circuit issue took place, this was a common feature in more than one space, and thus there are two evidences displayed above

Inference: *The study suggests that:*

- ➔ *Switchboards in every space should be **numbered as SB1, SB2 etc.** (Where SB stands for switchboard and 1/ 2/ 3 stands for numbers in the particular space)*
- ➔ *Similarly, the main boards or relevant boards should be demarcated appropriately as **MB1, MB2 etc. or Electrical duct, Fire duct etc.***
- ➔ *The **buttons should be named** as per usage such as lights/ fans/ appliance or any other use*
- ➔ ***As there has been an electrical circuit problem, there should be a walk-through audit to identify each and every switchboard that has a similar issue and undertake immediate replacement***

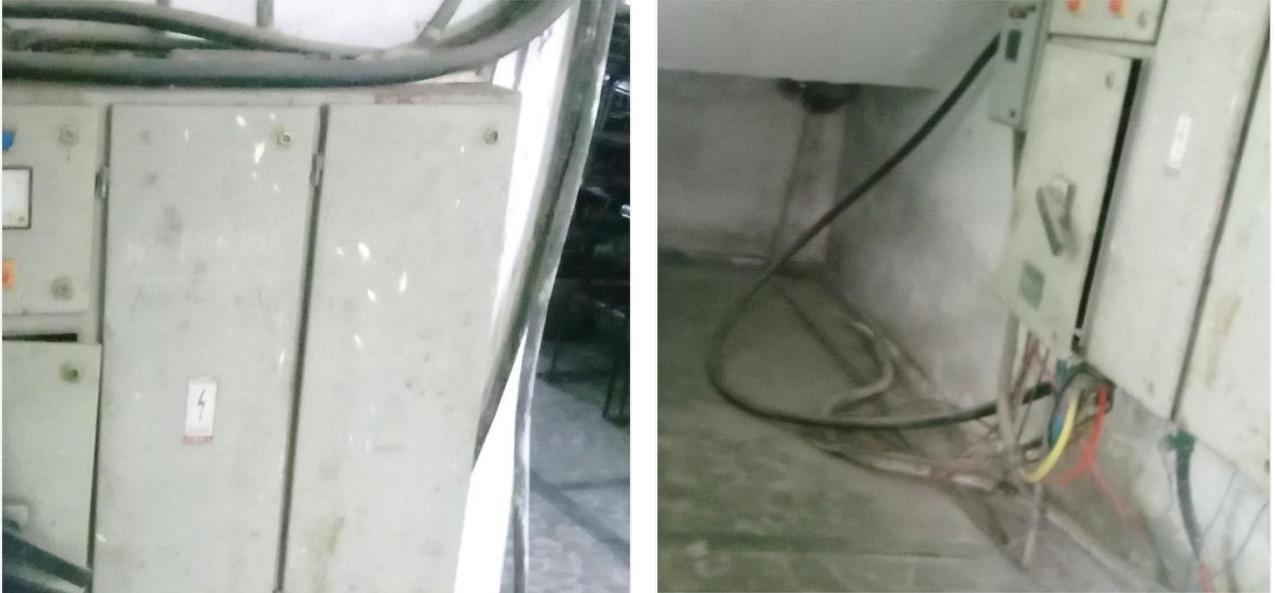
Plate 4: Electrical duct and backup

Observation: The spaces and facilities are not demarcated

Inference: *The study suggests that:*

- *These areas should be demarcated as '**Danger Zone**' with safety precautions such as signages, **fire balls/ sand bucket** should be places to avoid any fire accident*
- *The facilities should be named as per their usage (As per reference image below)*

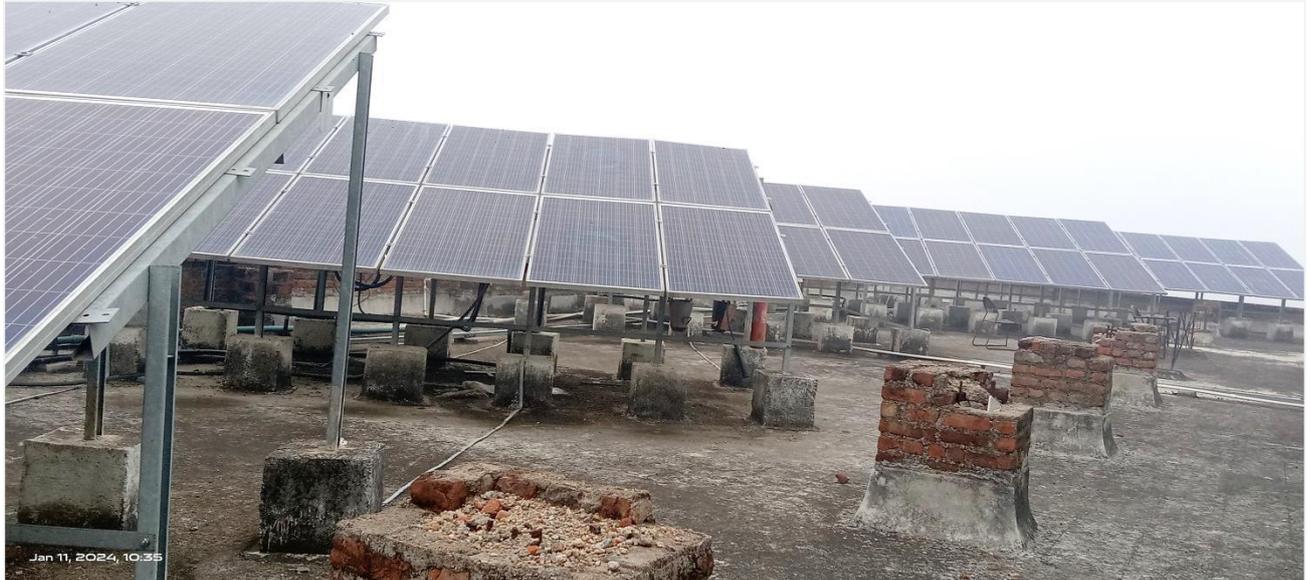
Plate 5: Alternate source of energy consumption

Observation: The maintenance of the space is not undertaken

- The rooftop panels were assessed and they are not well maintained.
- Additionally, **certain awareness posters in and around campus will be beneficial.**

Inference: *The study suggests that:*

- ➔ *The terrace flooring should be painted in 'Cooltop' every two years*
- ➔ *The area should be demarcated as 'Solar zone' with a manual about the system functioning process, its benefits etc.*
- ➔ *The **maintenance details** should be **reflected digitally, physically on an annual basis***
- ➔ *There should be a **display board** (as below) in the entrance of the premises, in addition to this board the manuals etc. will help in stakeholder sensitization*

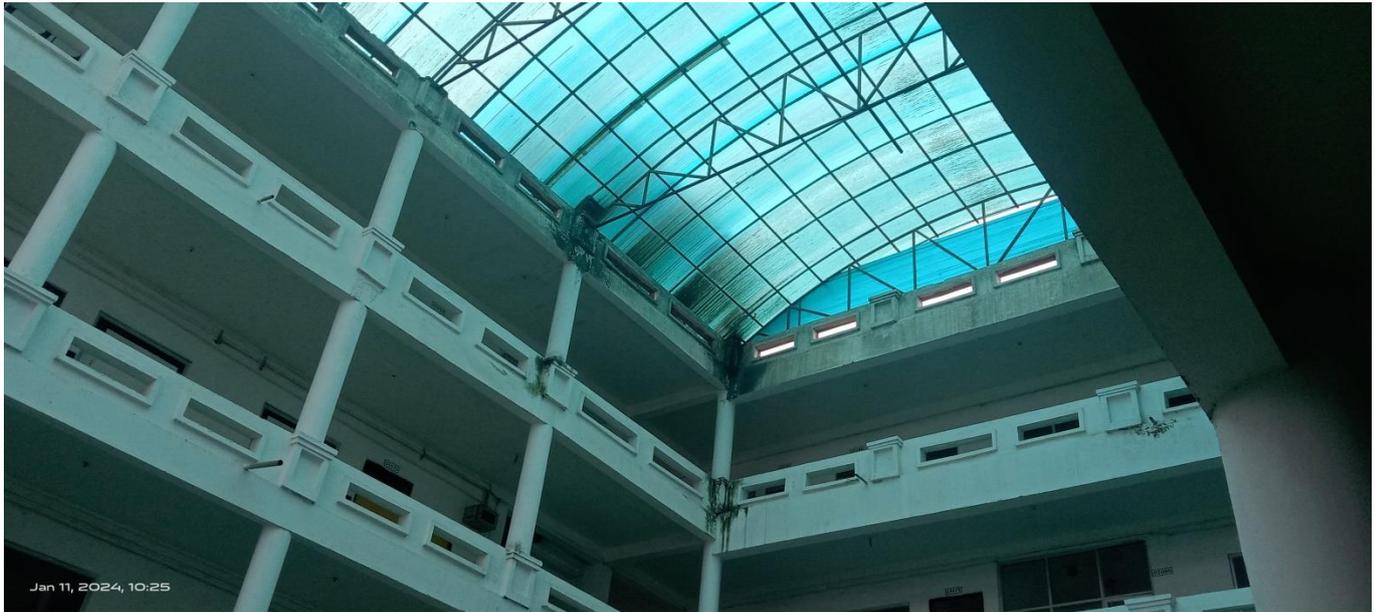
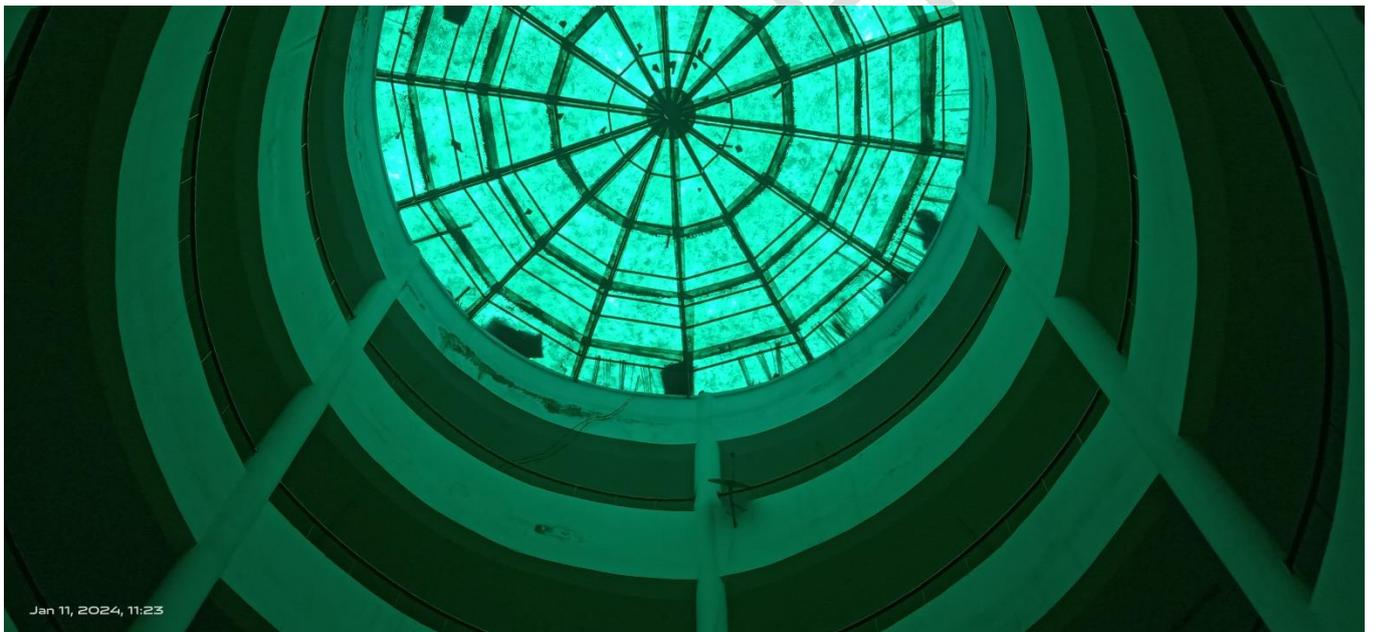
Plate 6: Skylight areas in he premises

Observation: The skylights as courtyard spaces acts as light wells and ventilation pockets

- ➔ *The rooftop areas are not maintained*
- ➔ *Once in a month rooftop cleaning is required*
- ➔ *The **junction of the rooftops** too require fabrication*

Inference: *The study suggests that:*

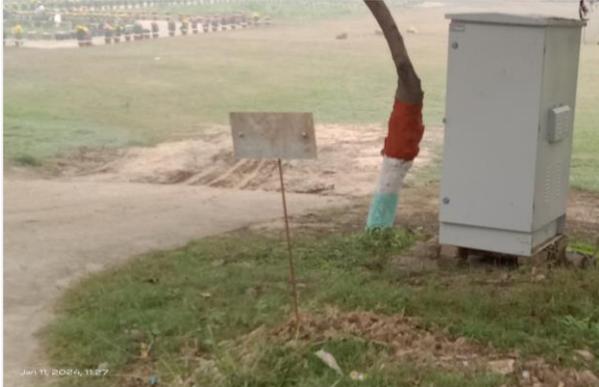
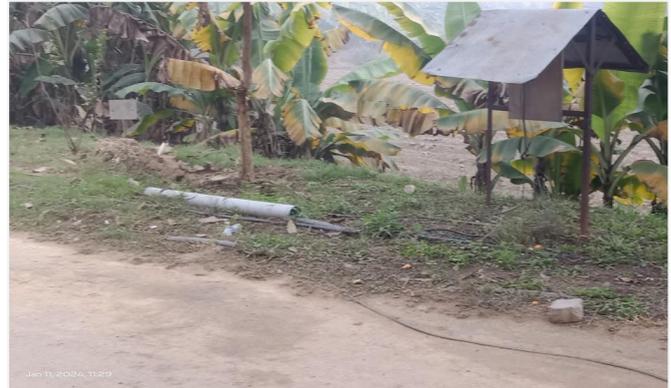
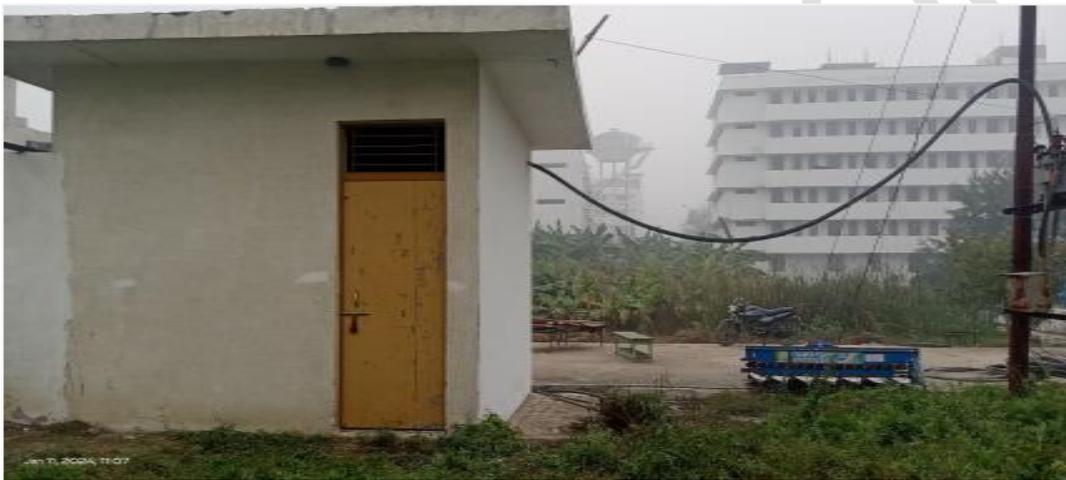
Plate 7: Electrical ducts (Earthing pits) and electrical room

Observation: The pits and areas are not coded

Inference: The study suggests that:

- ➔ The **earthing pits should be colour coded in brown colour** and numbered, a display board could mention their usage and last maintenance date
- ➔ The space such as should be demarcated as **'Danger zone'** with avoidance of any general public in the space
- ➔ On a similar note the **water harvesting pits can be colour coded as 'blue'** while the **service pits/ ducts as 'grey'** and the **fire ducts/ pits as 'red'**

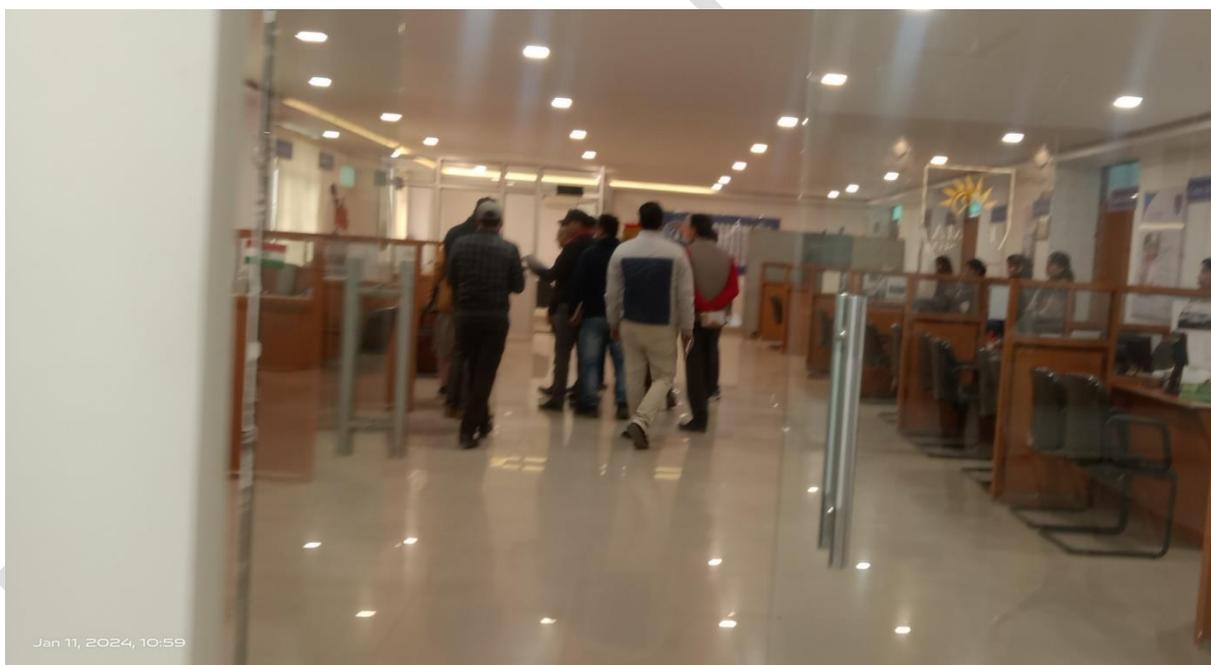
Plate 8: LED lights in the premises

The Institute has undertaken initiative of installing energy efficient appliance in the form of LED Lights; the Vice Chancellors Secretariat is the main block with majority of lights being LED

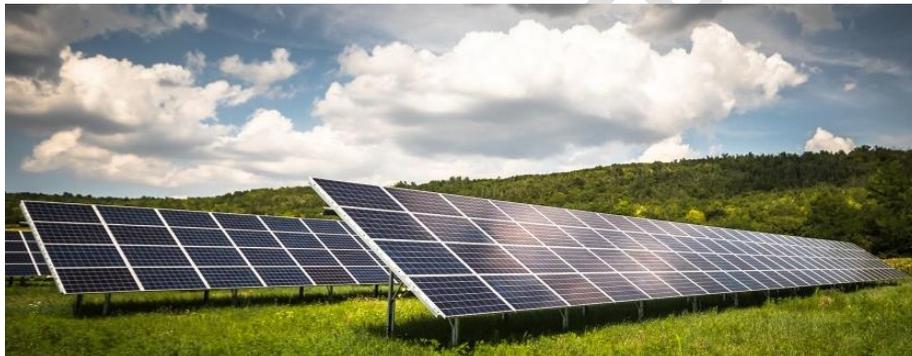
Reference suggestions 3: Solar farm concept for the Institute (For reference purpose only)

This option can be explored with due discussion with the surrounding and adjacent farmland owners. This will serve as a noble project and will provide dual benefits to farm land and Institute w.r.t to electricity bill power reduction.

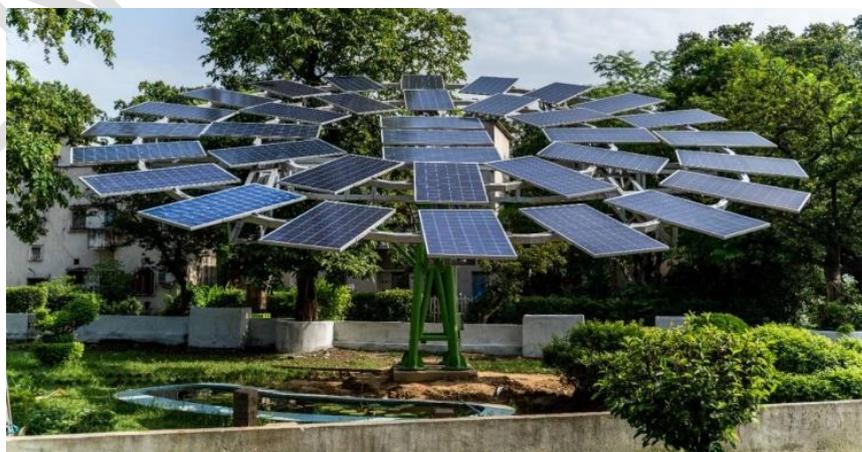
Reference suggestions 4: Solar tree concept for the Institute (For reference purpose only)

Since there is availability of space; the solar trees can be installed in multiple places as they will provide dual benefits of aesthetic and energy reduction.

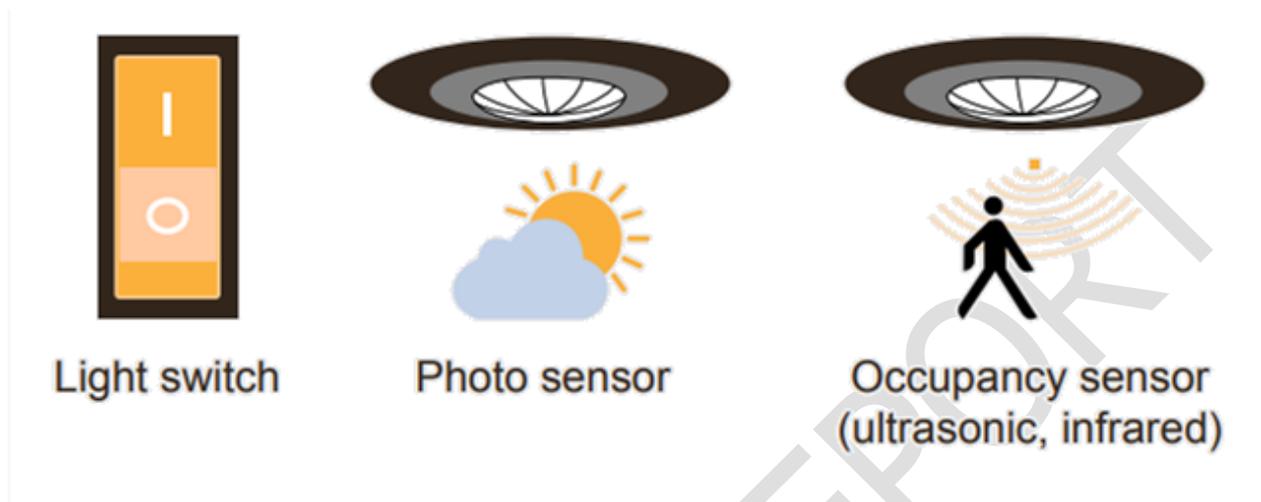
Reference suggestions 5: Understanding the lighting concepts

The above diagram provides a detailed study of how the system controls should be incorporated in the premises as far as lighting systems are considered. The suggestions for this sub-section are listed below.

- ➔ Install PIR control of the lighting in the toilet areas.
- ➔ Install low flow taps with automatic shut off in the toilets.
- ➔ Install push button timer control in all rooms lighting and ceiling fans.
- ➔ Install Power Electronics control of the Foyer notice board lighting.
- ➔ Installation of intelligent lighting controller will help in controlling the lighting energy.
- ➔ Use of photo sensor switch for street light controlling helps in conserving the lighting energy.

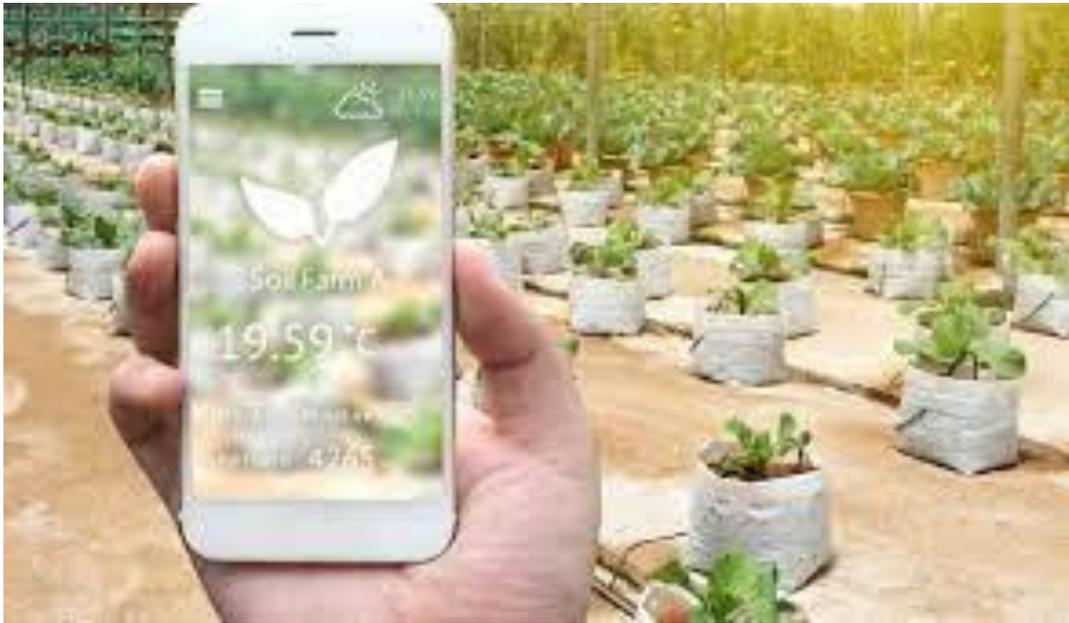
Reference suggestions 6: Solar farm concept for the Institute (For reference purpose only)

The Institute can undertake a Smart Gardening system using IoT Technology. This will result in saving time by scheduling time for watering; saving money through automated water schedules tracking dampness of soil to know when, how much water garden needs.
